CONVERSION OF GULLIES TO VEGETATION-LINED WATERWAYS ON MOUNTAIN SLOPES

BY BURCHARD H. HEEDE

7 (U.S. Rocky Mountain Forest and Range Experiment Station, +7a
Forest Service, • U.S. Department of Agriculture
Raymond Price, Director
5a Fort Collins, Colorado

1968. Conversion of gullies to vegetation-lined waterways on mountain slopes. U. S. D. A. Forest Service Research Paper RM-40, 11 pp., illus. Rocky Mountain Forest and Range Experiment Station, Fort Collins, Colorado 80521.

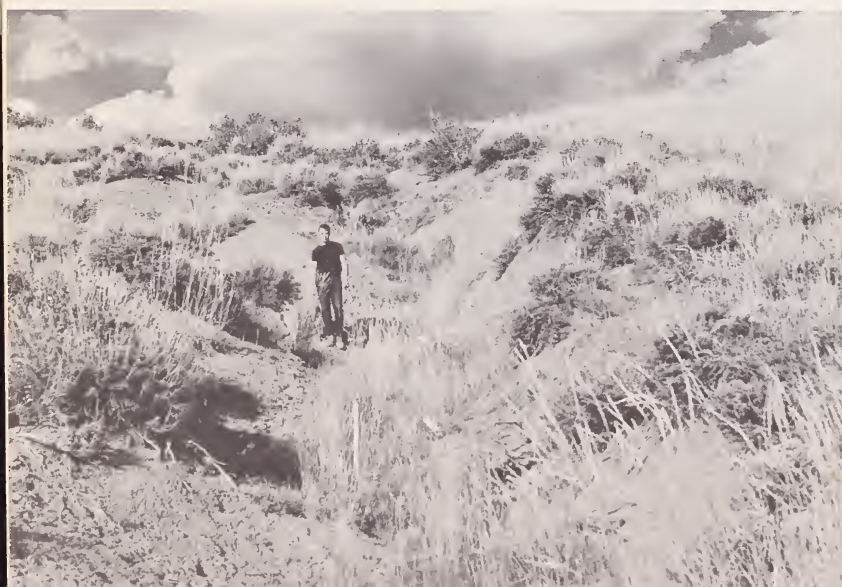
Figure 1.--Gully No. 12 typifies conditions that existed before waterway construction.

Four gullies of medium size were selected for treatment (fig. 1, table 1). To represent the major aspects of the watershed, the gullies were chosen on north, south, and southwest aspects. Four gullies with aspects similar to those of the treated gullies and located adjacent to them were selected and left untreated, to evaluate future treatment effects.

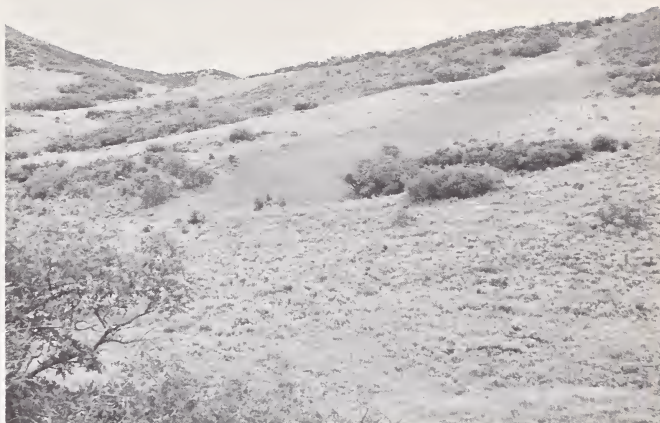
Figure 3.--The former gully of this waterway had an average gradient of 20.5 percent. Gradient of the new watercourse is 17.4 percent. Note the transition zones from the undisturbed hillside into the starting area of the waterway and between mouth of waterway and hillside.

Waterways have two transition zones: one at the upstream end where the undisturbed drainage joins the waterway, the other at the downstream end where the mouth of the waterway discharges the flow (fig. 3). Both places received special attention in the design to achieve gentle transition.

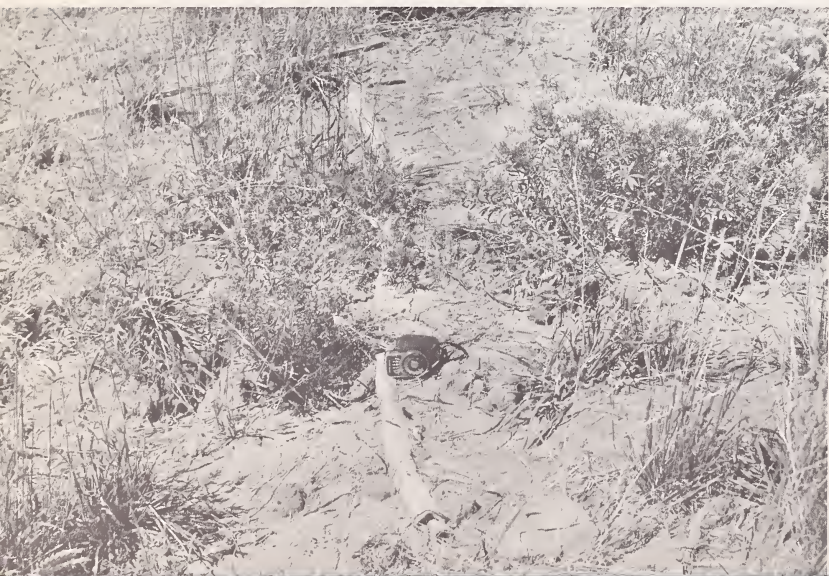
Figure 4.--Burlap checks were installed to spread concentrated flows and to prevent the fusion of discontinuous rill gullies. Photo taken on waterway No. 6, September 2, 1964.

To prevent the formation of continuous gullies during future spring melt flows, burlap checks were installed at a spacing of 5 feet in the fall of 1964 on those parts of the watercourses where discontinuous rill gullies had started. The checks consisted of sheets of burlap folded into strips approximately 0.75 foot wide. Trenches, crossing the watercourses at right angles, were dug with a plow pulled by a team of horses. The strips were placed in these trenches so that 0.2 foot remained above ground level (fig. 4). Then the trenches were filled and grass was sown on the disturbed areas. These burlap checks prevented the fusion of the discontinuous rill gullies during the following snowmelt flows. Because the checks forced the flows to spread out, soil was deposited upstream from the checks, and the rills decreased in size.

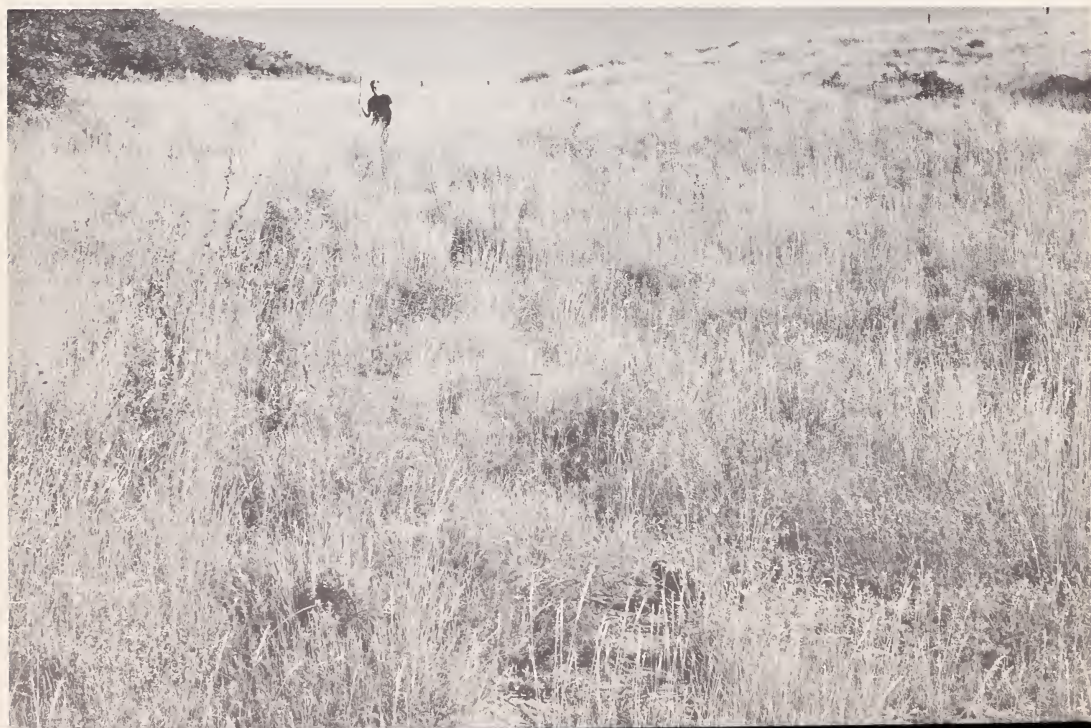
Figure 5.--Upstream view of waterway No. 6, 4 growing seasons after construction. The former gully was located at the edge of the oakbrush on the left. The thalweg of the waterway is to the right of the man. Photo taken September 13, 1965.

not yield specific solutions to important problems in the flow-soil-vegetation relations. Its main merit is to have demonstrated that, under the prevailing conditions, gullies on mountain slopes can be successfully converted to vegetation-lined waterways (fig. 5). This was illustrated by the facts that:
